Collapses and Damage to Swedish Farm Buildings Due to Snow Loads

Christer Nilsson^{1*}, Olof Friberg²

Abstract

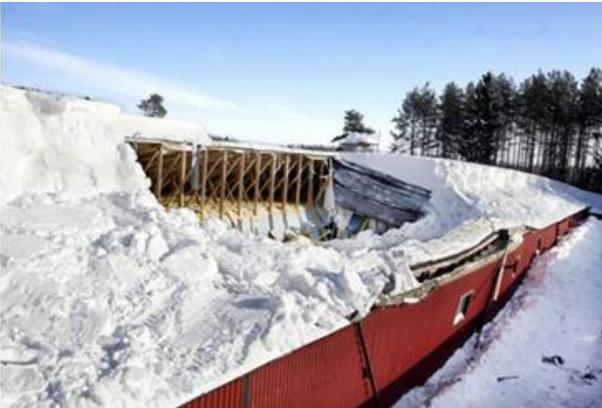
FIGURE 2. Unsymmetrical roof snow load due to prevailing wind from the left side in the picture when snowing, resulting in collapse.

Normative ground snow quantities were only very occasionally exceeded. However, for many objects it could be verified that unsymmetrical snow load had occurred on the roof, mainly due to prevailing, continuous wind in combination with temperature below zero. Also snow pockets in the roof valley between attached houses could be shown to have resulted in damages. Unsymmetrical snow load had also occurred when the snow had not been well thought-out shoveled away from the roofs.

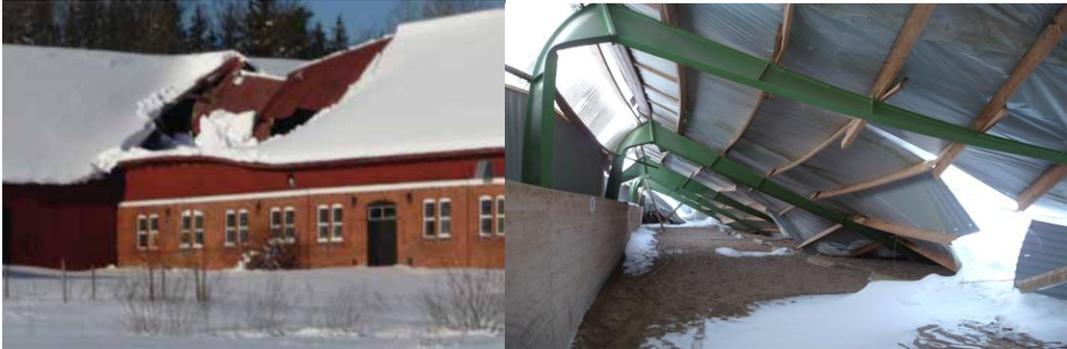
FIGURE 3. Left: Roof collapse caused by high snow load in the roof valley. Right: Collapsed roof of a riding arena due to undersized 3-hinge frame structure. The frame was dimensioned for too low snow load (wrong snow zone).

When the building or part of it is imported or bought from places with other climatic conditions it is important to make sure that correct snow load is assumed. Future research and development work related to the agricultural building process is of importance.

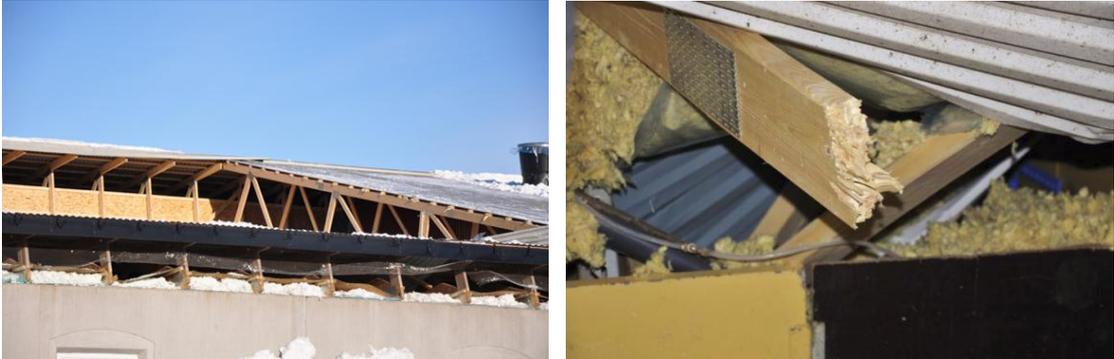
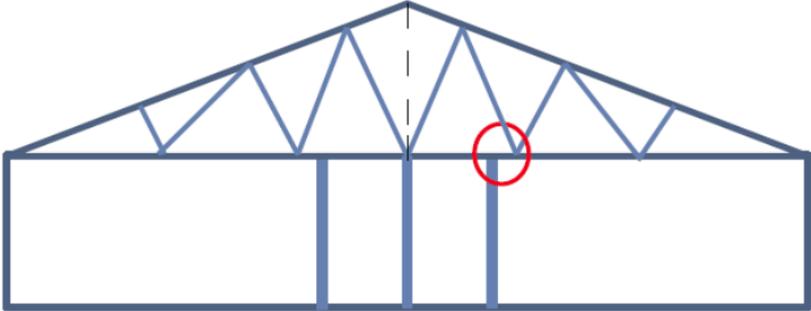
FIGURE 4. When exposed to high snow load the ceiling joists of the W-trusses deflected downwards so much that they unintentionally were supported by a non-loadcarrying interior wall. This resulted in bending ruptures in the ceiling joists.

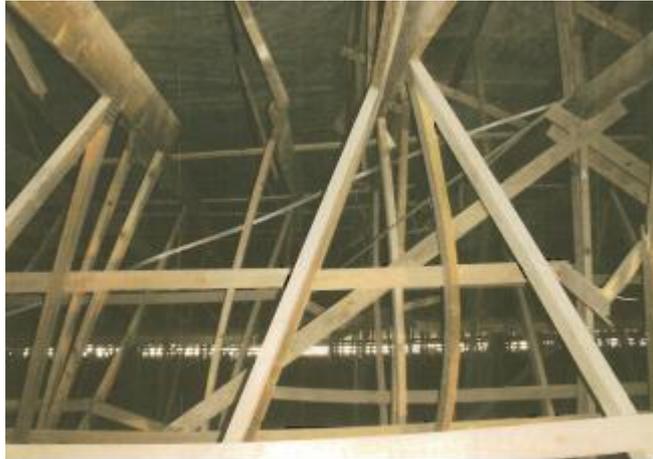
FIGURE 5. Insufficient braced compressed diagonals of W-trusses. Progressive collapses of the trusses has also been initiated.

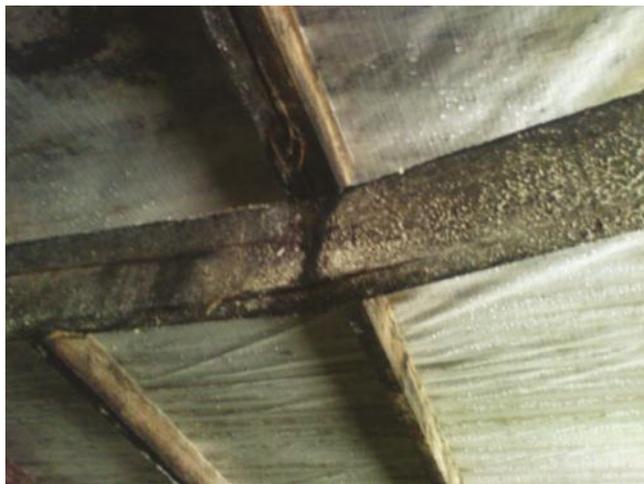
Additionally, lack of maintenance e.g. leaking roofs resulting in decay or corrosion could be shown to be, at least contributing, grounds for damages.

FIGURE 6. Insufficient ventilation of the livestock house has made the roof ridges become rotten resulting in decreased strength. Extreme snow load revealed the bad conditions.
